Inspection Report for Structure 007773

007773 - CO. RD. 87 over STYX RIVER

Inspection Date: 12/11/2024

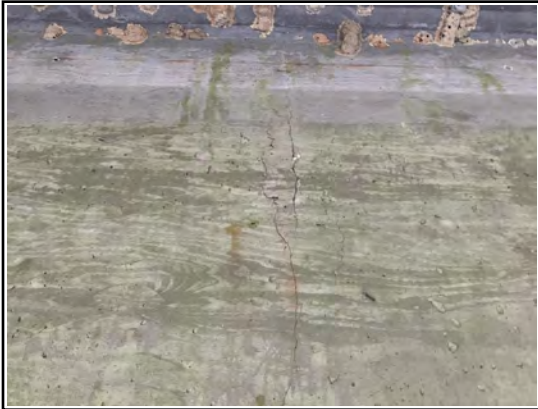
delam girder 2 span 11 left face

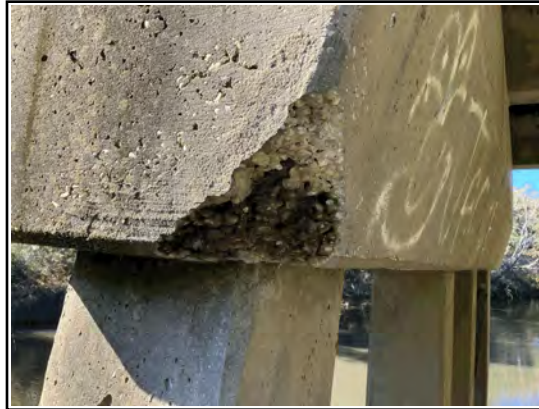
spall bent 11 cap right side

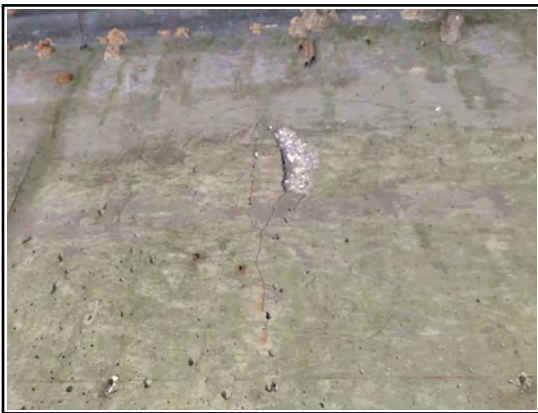
delam girder 2 span 11 left face

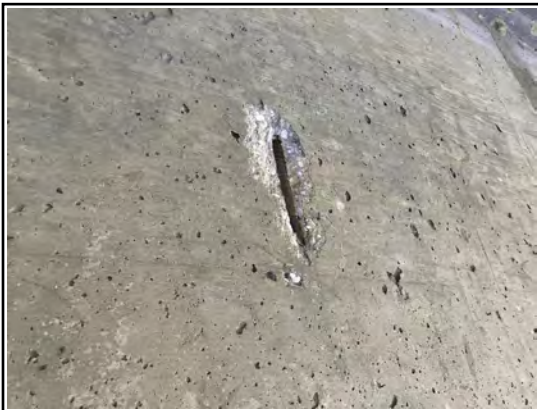
spall girder 2 span 11 right face

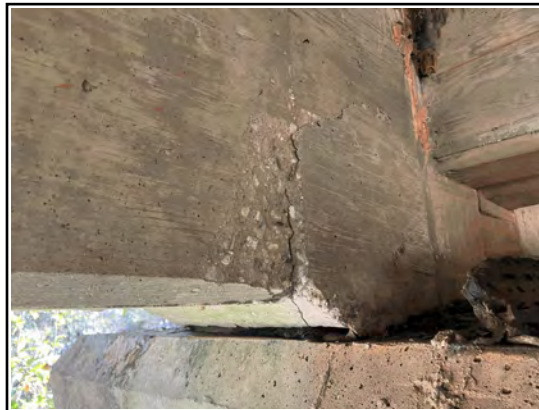
Super 5: Vertical hairline cracks on girders on span 10, minor areas of exposed rebar. Shear crack span13 girder 3.

delam span 13 girder 3

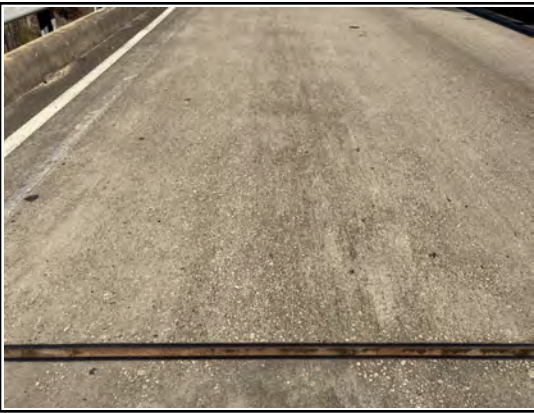
joint

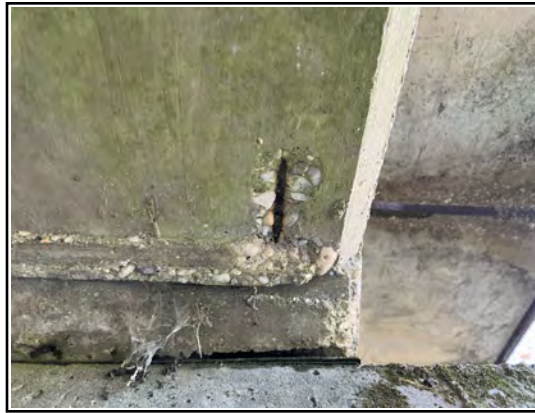
<u>Elem No.</u>	<u>Element</u>	<u>Env</u>	<u>Total Qty</u>	<u>Unit</u>	<u>CS 1</u>	<u>CS 2</u>	<u>CS 3</u>	<u>CS 4</u>
<input type="checkbox"/>	Current: 16	Re Conc Top Flange	Low	14,695	sq.ft	0	14,688	7	0
	New:								
	Notes:								
<hr/>									
	Current: 1130	Cracking (RC and Other)	Low	1,885	each	0	1,884	1	0
	New:								
	Notes:	hairline crack down centerline of bridge.							
<hr/>									
	Current: 1190	Abrasion(PSC/RC)	Low	12,810	each	0	12,804	6	0
	New:								
	Notes:	3x2 area of abrasion CS 3 span 4							
<hr/>									
<input type="checkbox"/>	Current: 110	Re Conc Opn Girder/Beam	Low	1,884	ft	1,857	24	3	0
	New:								
	Notes:	-							
<hr/>									
	Current: 1080	Delamination/Spall/Patched Area	Low	6	each	0	6	0	0
	New:								
	Notes:	minor spalls throughout							
<hr/>									
	Current: 1090	Exposed Rebar	Low	2	each	0	0	2	0
	New:								
	Notes:	areas of exposed rebar show minor section loss

exposed rebar span 6 beam 1

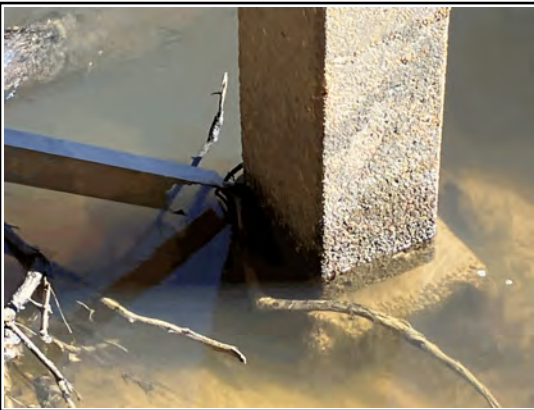
Sub 7: Failed x bracing at bents near channel and bent 3, steel pile encasements show abrasion at channel. All piles have steel encasements to the mudline.

abrasion

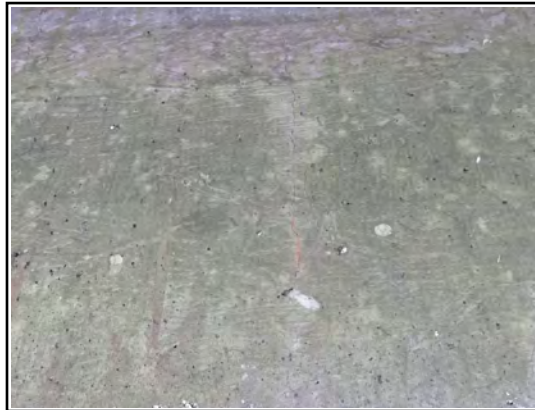
<hr/>									
	Current: 1130	Cracking (RC and Other)	Low	19	each	0	18	1	0
	New:								
	Notes:	cracking on griders span 10							
<hr/>									
<input type="checkbox"/>	Current: 215	Re Conc Abutment	Low	64	ft	64	0	0	0
	New:								
	Notes:	-

cracks span 10 girder 3

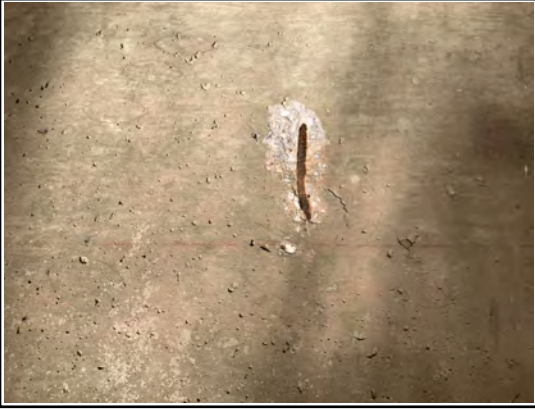
rebar span 10 girder 2

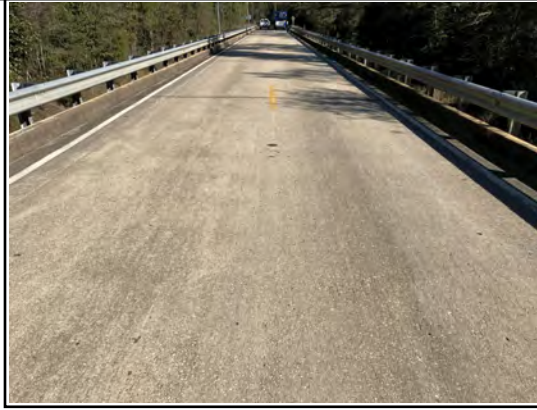
Deck 6: Due to abrasion throughout deck. hairline crack down centerline of bridge

deck

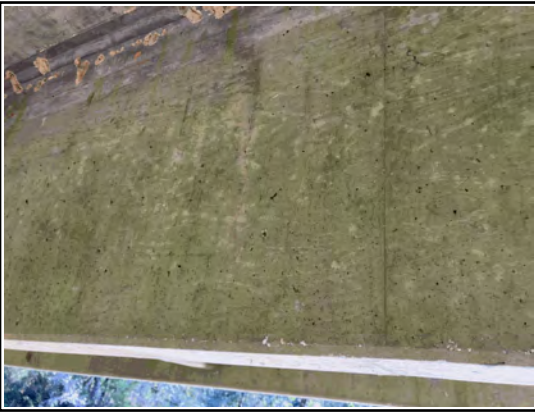
cracks in girder 3 span 10

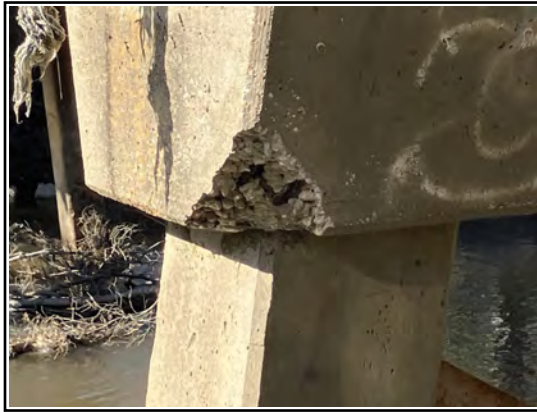
spall bent cap 11 right side

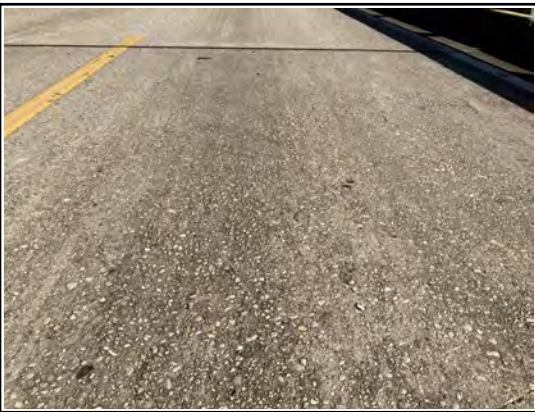
deck abrasion

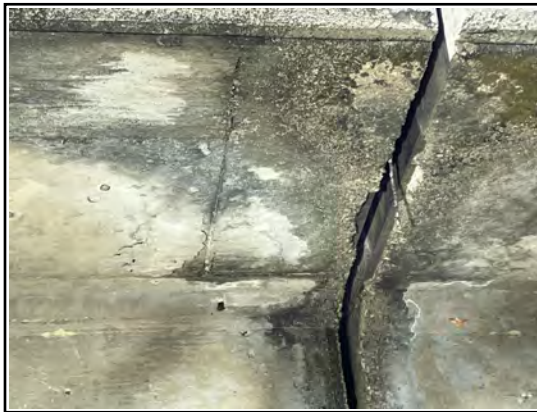
delam right overhang at bent 10 span 9
