Inspection Report for Structure 005964

005964 - CO. RD. 64 over STYX RIVER

Inspection Date: 12/11/2024

Inspection Date: 12/9/2025

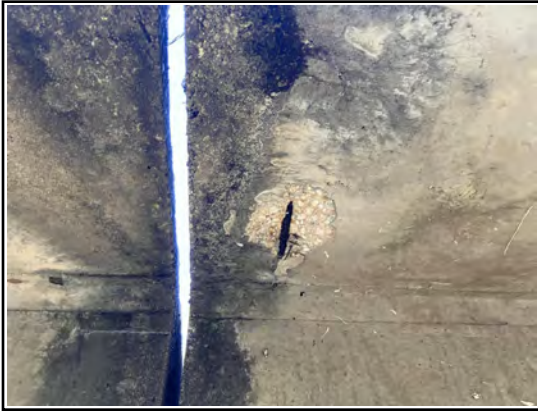
spall span 4 right overhang at bent 4

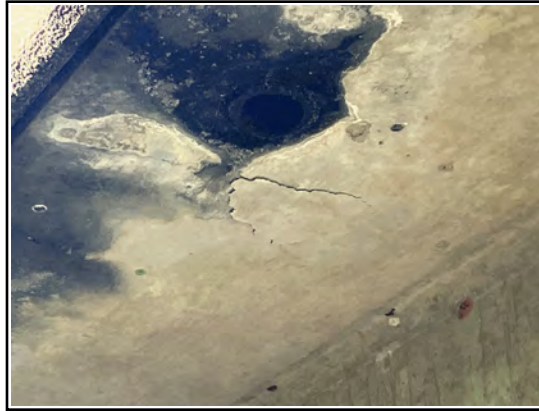
delam span 4 right overhang

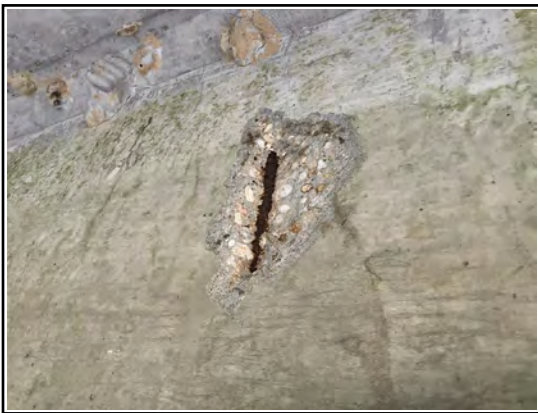
spall span 4 girder 2 left face

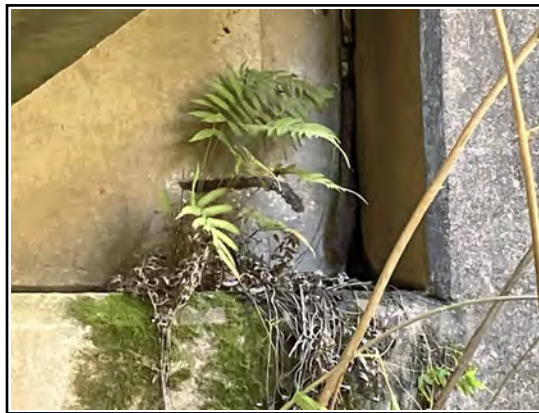
exposed rebar abut 1 near beam 1

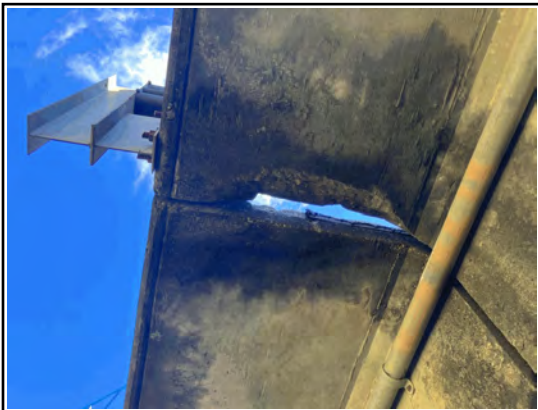
spall span 3 left overhang at bent 4

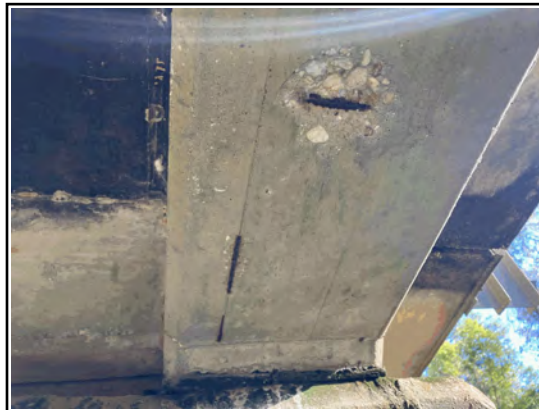
Super 5: Various minor spalls and areas of exposed rebar. Shear crack bent 7 G3 outside face

exposed rebar girder 3 at bent 7

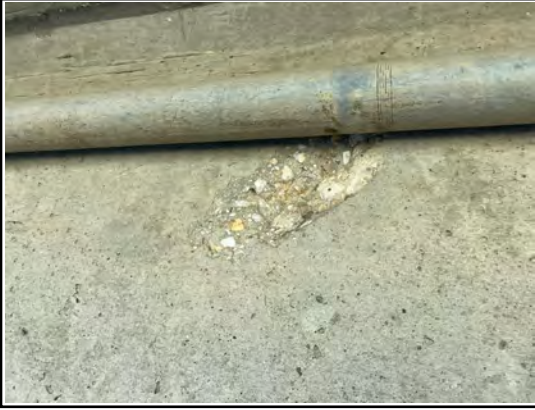
spall span 4 outside of girder 1

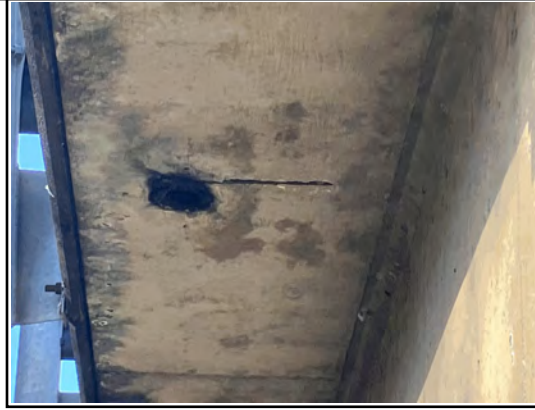
spall span 6 right overhang

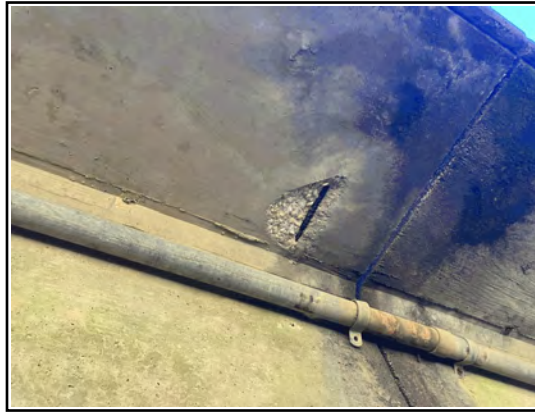
spall span 3 left overhang at bent 3

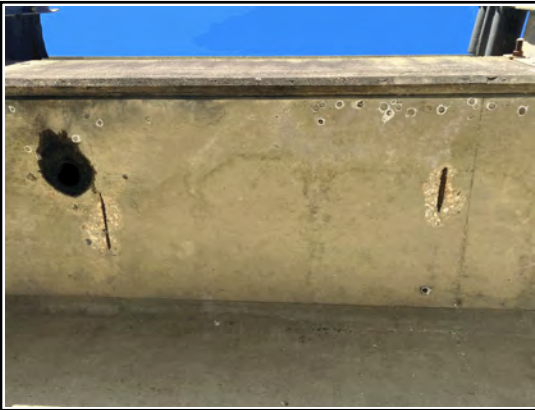
spalls span 4 right overhang

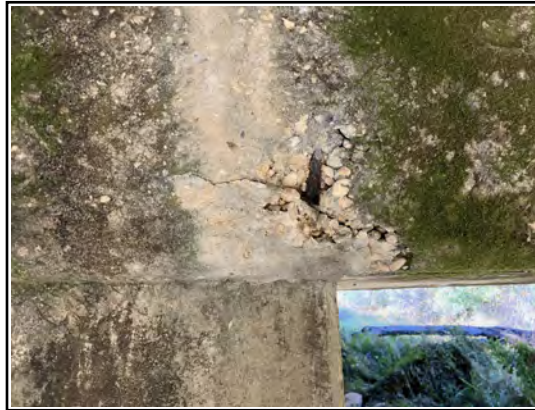
spall bent 3 cap over pile 2 far face

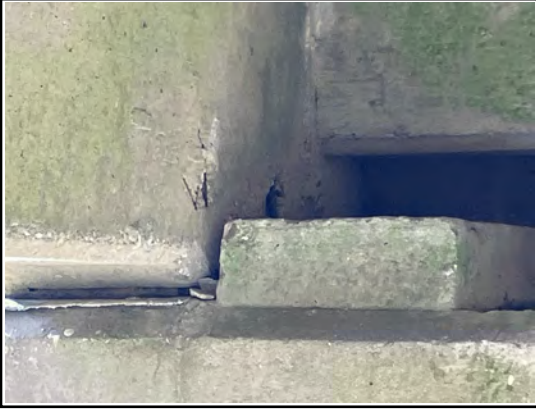
spall inside beam 3 at bent 6

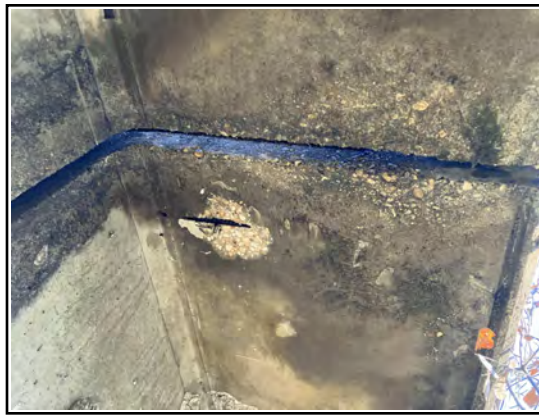
spall right overhang at bent 4

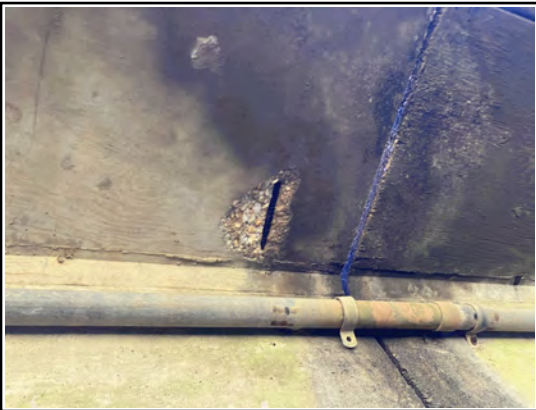
spall left overhang at bent 3

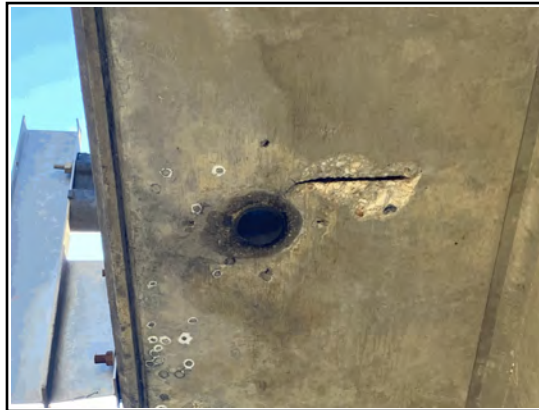
spall right overhang span 5

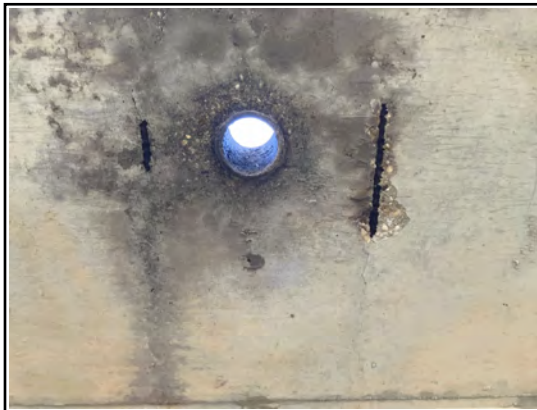
delam right overhang span 4

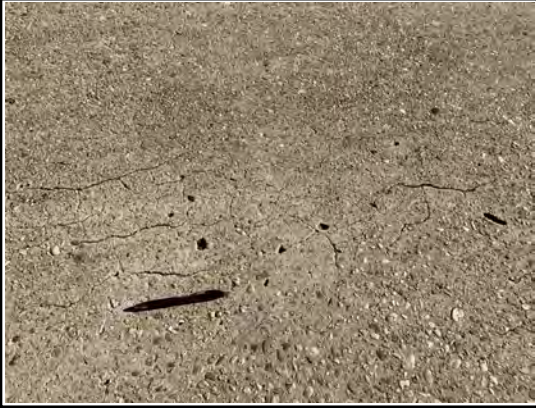
Deck 5: Deck shows several areas of map cracking Spans 1-3 and 14. Armor plating has been removed multiple joints and the concrete is starting to spall. Abrasion exists throughout: all armor plates have been removed, all joints show spalling

deck map cracks span 2

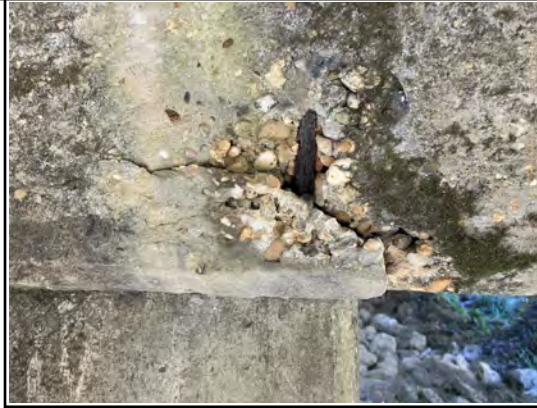
spall bent cap 3 span 3 over pile 2

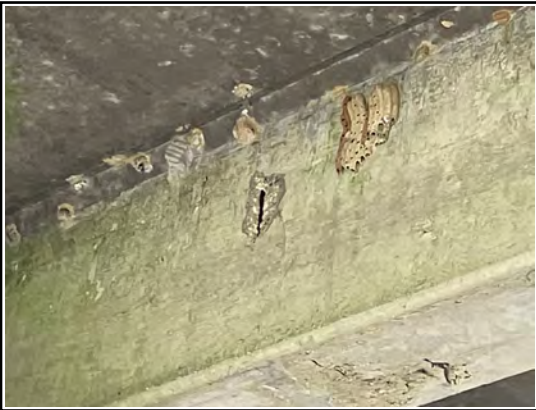
spall span 4 beam 2

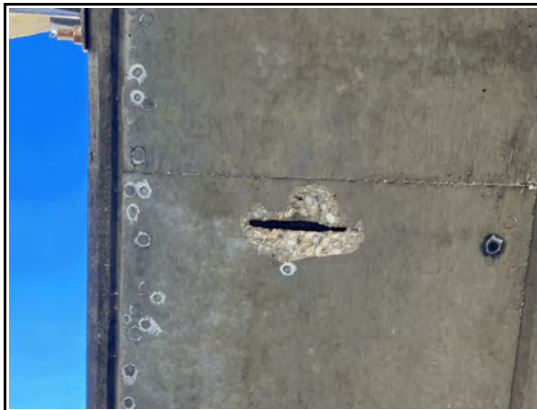
spall right overhang span 5

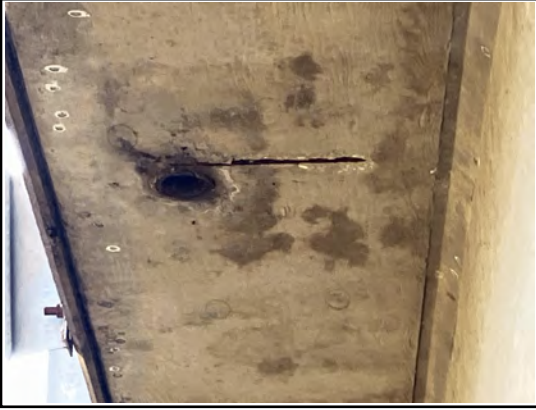
spall right overhang span 5

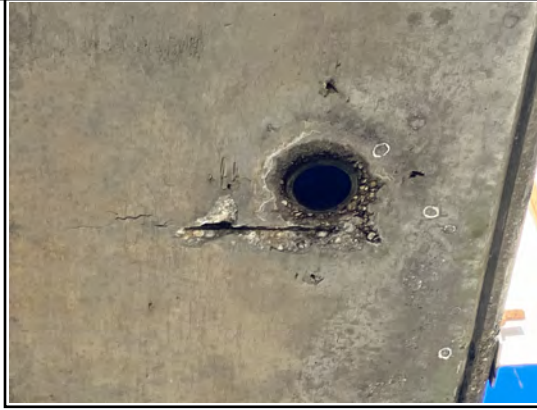
spall right overhang span 5

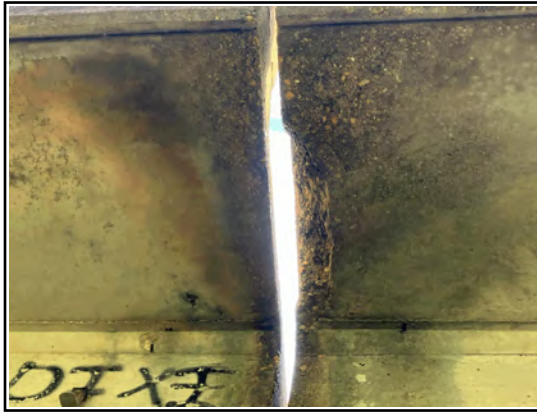
spall left overhang at bent 8

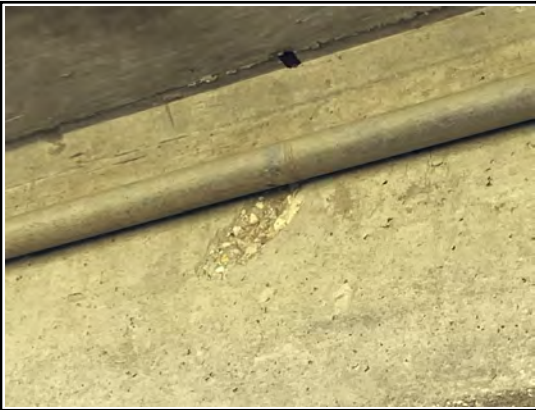
spall span 4 outside beam 1

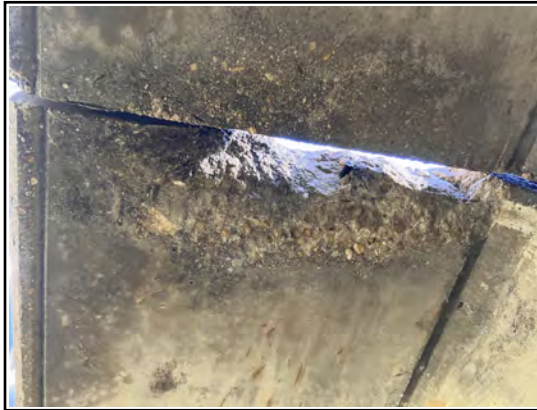
spall left overhang at bent 13

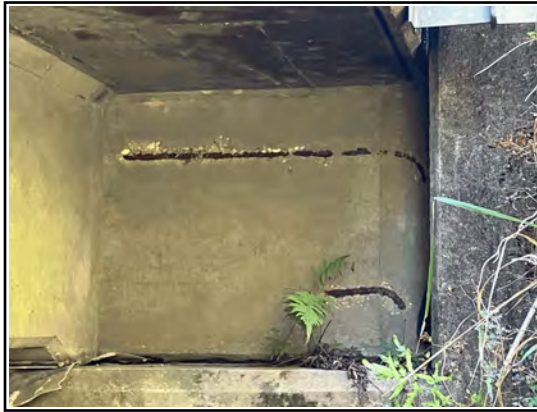
rebar at abut 1 near wing
