Inspection Report for Structure 005963

005963 - COUNTY RD. 61 over DYAS CREEK

Inspection Date: 12/17/2024

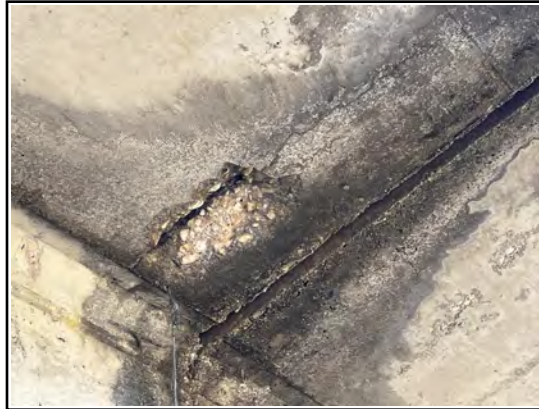
spall right overhang at bent 10

Date Recommended: 03-22-01 Priority: Medium
 Estimated Quantity: 80 Unit Cost: \$276 Estimated Cost: \$22,080
 C: _____ New Quantity: _____ New Priority: _____
 Notes: clean/patch spalls as needed.
 New Remark: _____

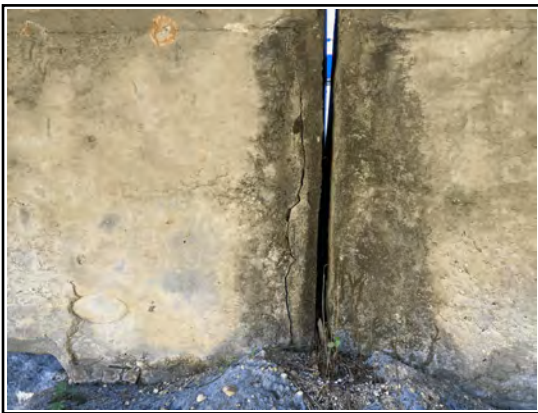
Current:	1130	Cracking (RC and Other)	Low	4	each	0	0	4	0
New:									
Notes:	shear cracks at bent 4,5, and 10 vertical crack outside beam 1 at bent 2 - 18"

vertical crack beam 1 at bent 2

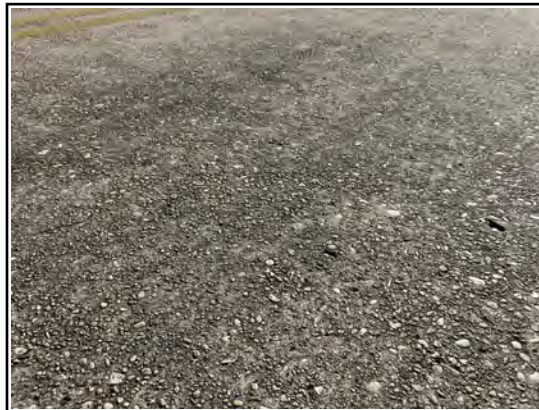
Deck 6: Due to abrasion and moderate map cracking

deck abrasion

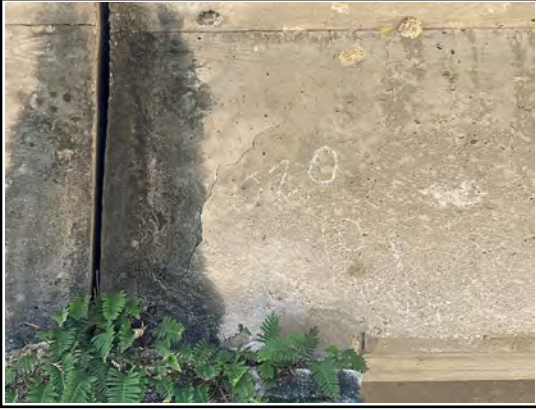
Super 5: Several spalls with exposed rebar on girders and shear cracks located at bent 4, 8 and 10.

shear crack beam 1 at bent 10

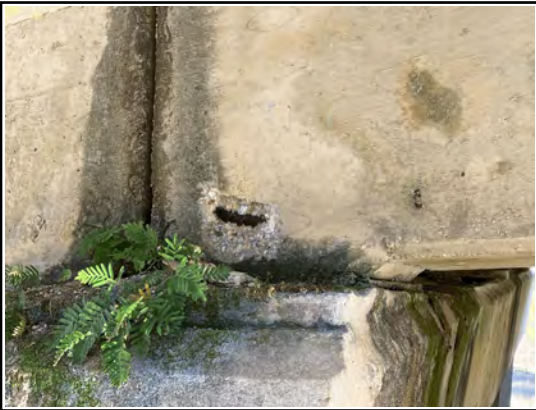
spall beam 1 at bent 9

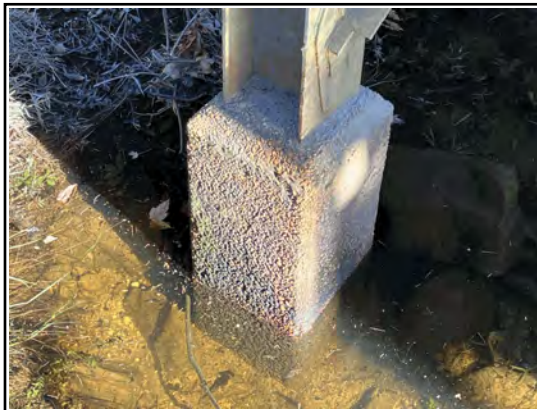
abrasion on piles

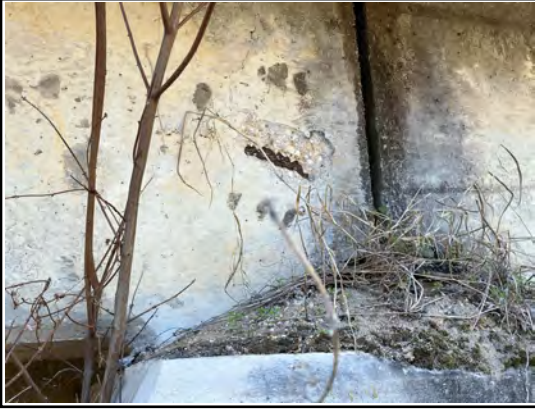
spall beam 3 at bent 9

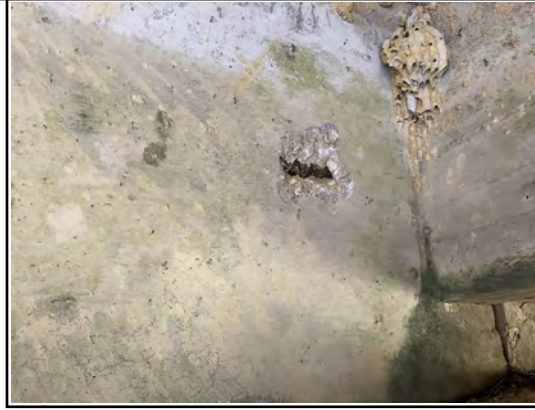
spall beam 2 at bent 9

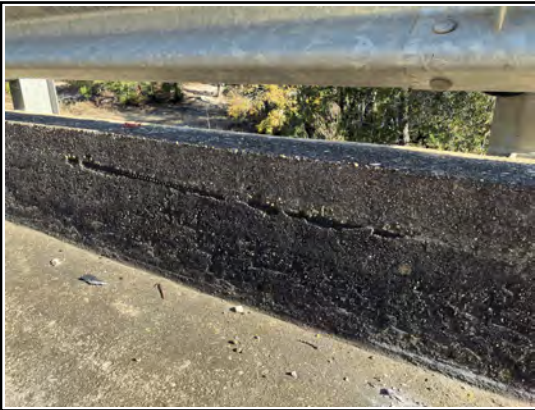
rebar right curb span 6
