Baldwin County Highway Department
Speed Limit Change Checklist

Location: County Road 93 (Sunset Dr. to Faircloth Rd)
Functional Classification: Local/Rural
Current Posted Limit: 45-SB MPH Proposed Limit: 35 MPH
35-NB

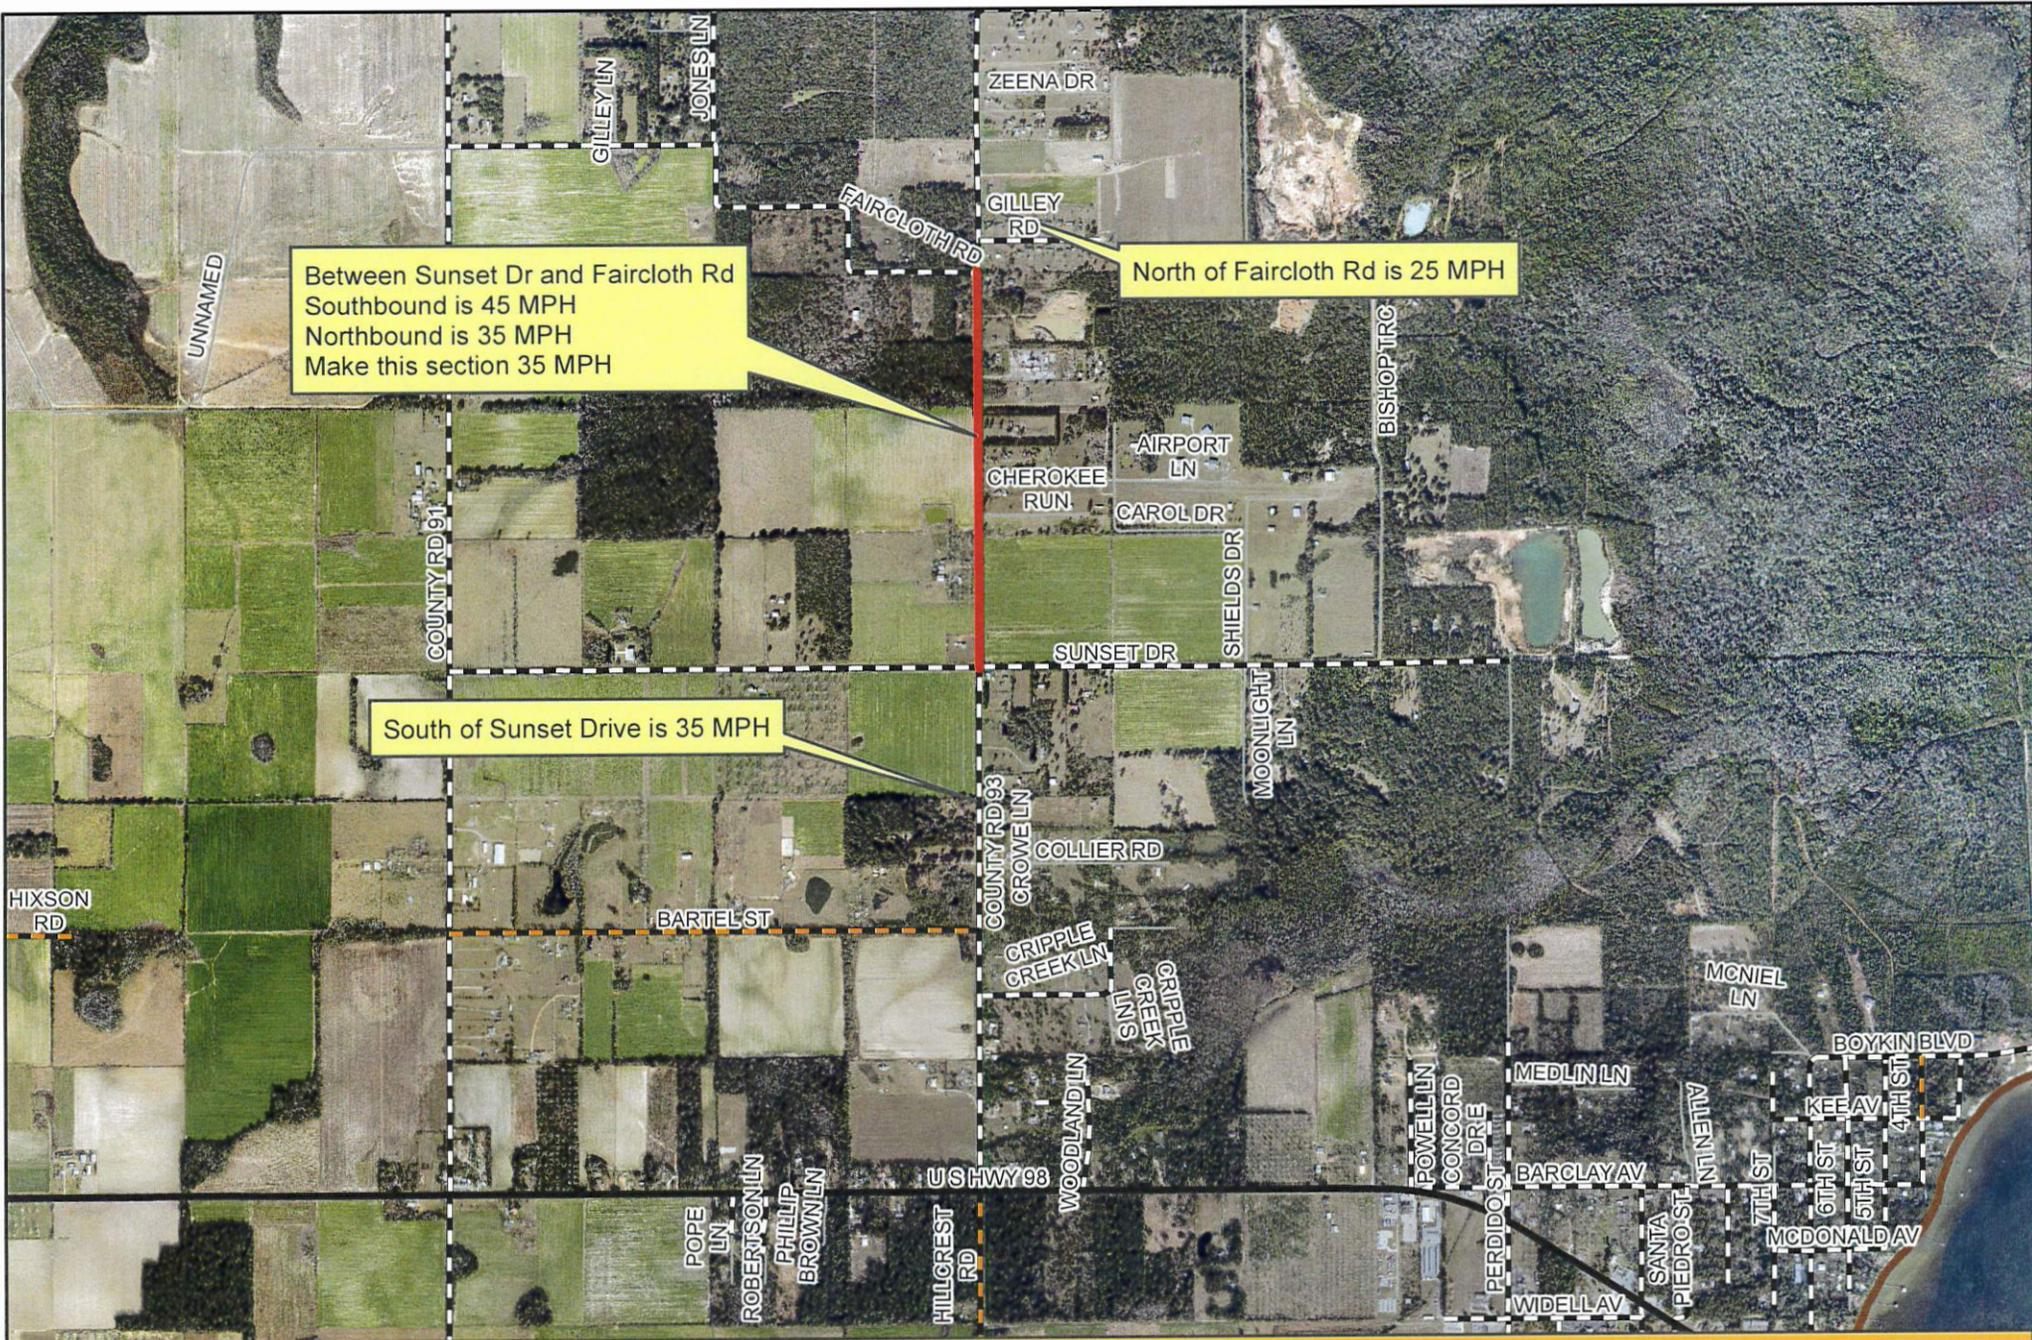
Between Sunset Dr and Faircloth Rd
 Southbound is 45 MPH
 Northbound is 35 MPH
 Make this section 35 MPH

North of Faircloth Rd is 25 MPH

South of Sunset Drive is 35 MPH

Adjust the speed limit between Sunset Dr and Faircloth so that the speed limit is 35 mph in both directions.
