### ACCA / IAC ARPA FUNDING APPLICATIONS

### BALDWIN COUNTY PROBATE JUDGE'S OFFICE

### BAY MINETTE, ALABAMA

JUNE 10, 2022

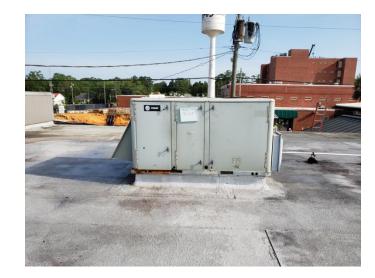
ROOFTOP DX COOLING HEAT PUMP UNITS							
UNIT	ROOFTOP UNIT	TONS	REFRIG	APPROX. UNIT AGE	FILTER	MOTORIZED DAMPER	OSA
RTU-01	Trane THC120A3RKAG1FB0A, Serial No. 435100283L	10	R-22	2004	2"	Yes, but disabled	Yes
RTU-02	Trane TFD151C300BA, Serial No. 43510322D	12.5	R-22	2004	2"	Yes, but disabled	Yes
RTU-03	Trane Model THC120A3EKA1FB0A, Serial No. 435100082L	10	R-22	2004	2"	Yes, but disabled	Yes
RTU-04	Trane THC120A3EKA1FB0A, Serial No. 435100014L	10	R-22	2004	2"	Yes, but disabled	Yes
RTU-05	Trane Model THC092A3RGA18B0A, Serial No. 435100080L	7.5	R-22	2004	2"	Yes, but disabled	Yes

- Many of the existing systems are older and close to their end of life. These units will not handle current code required outside air and maintain temperature and humidity within the space. Recommend upgrading systems to include both temperature and humidity control. This would require upgrading approximately five (5) existing rooftop units.

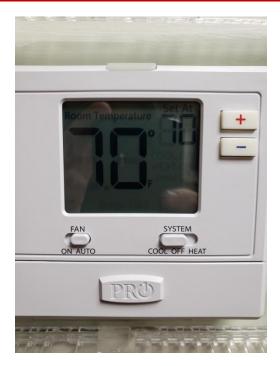
1. The building had standard programmable thermostats.

- 1. Recommend upgrading controls to allow for temperature and humidity control with remote access using communicating thermostats.

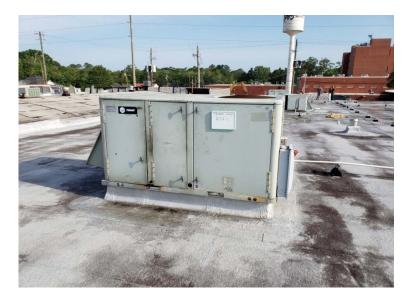
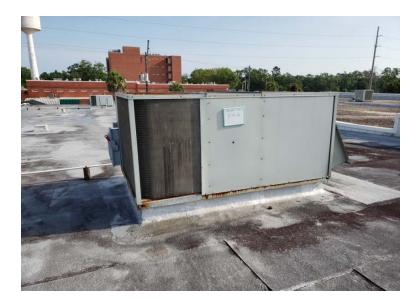
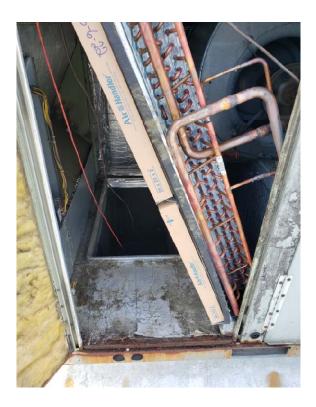
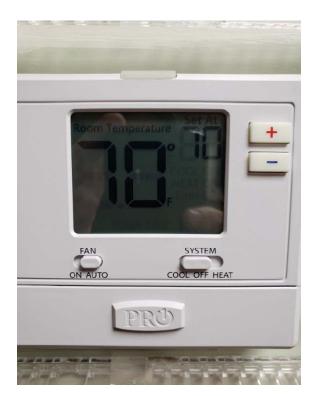
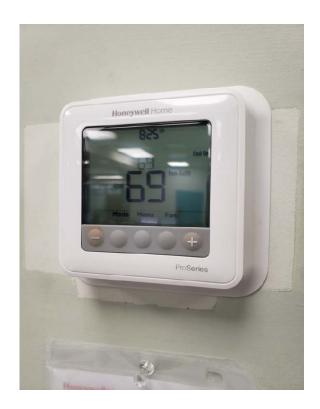
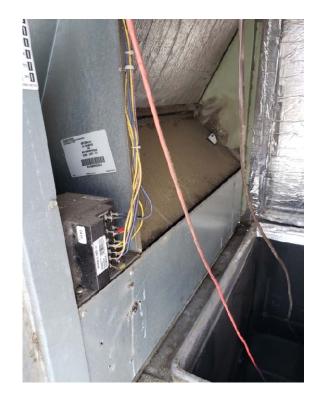
PHOTOS:

EXISTING CONDITIONS:				
Existing Mechanical Units	Packaged Heat Pumps			
Existing Age of Mechanical Systems	Approximately 2004			
System Controls	Programmable Thermostats			
Do controls have remote access	No			
Are unit fans set to "on" in lieu of "auto"	No			
Do units control by temperature and humidity	Temperature Only			
Existing Filtration	2" Pleated Filter			
Are existing HVAC units capable of higher filtration	Νο			
Is there room in existing HVAC units for coil mounted UV-C	Yes			
Code Required Outside Air	No, Motorized Dampers are Disabled			
Does outside air to units have motorized dampers and/or manual dampers	Motorized, but broken/ disconnected			
Evaluate building pressure	Positive			
Public Restrooms Faucets (Manual / Touchless)	Manual			
Public Restrooms Flush Valves (Manual /Touchless)	Manual			
Pictures	See Below
