Inspection Report for Structure 005963

005963 - COUNTY RD. 61 over DYAS CREEK

Inspection Date: 12/17/2024

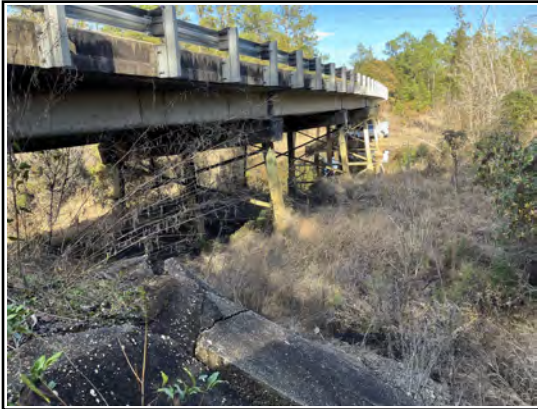
downstream side

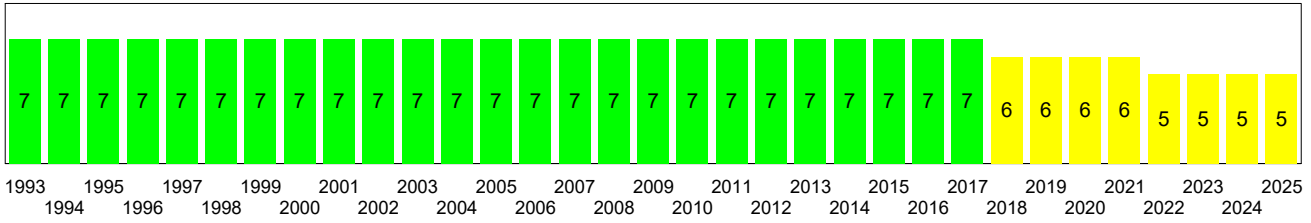
Superstructure Rating

Super 5: Several spalls with exposed rebar on girders and shear cracks located at bent 4, 8 and 10.
